Willard Says.....

Everyday Wisdom on the
Workings of a Hydraulic Dredge

What is Wrong in this Picture?

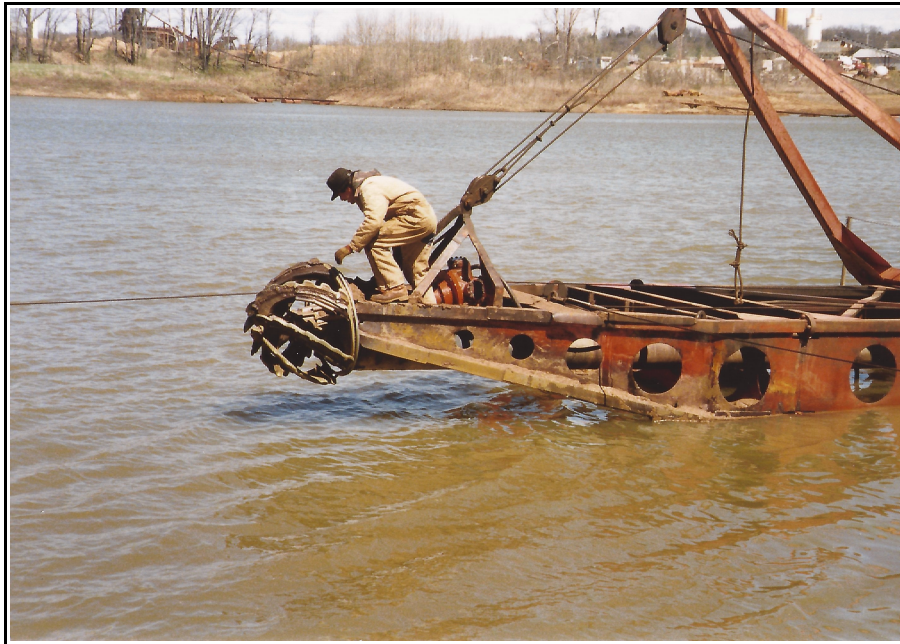
Figure #1

Six problems loom large in this picture of a rotary cutter dredge ladder.

Safety! Safety! The operator is not wearing a life jacket. Normally, no one is around to fish him out should he fall into the water. He is on his own.

Design deficiency! The ladder frame is not only straight, it bends upward at the cutter end. This arrangement causes heeling off which occurs when the bottom of the ladder just aft of the cutter basket comes to rest on a bank of solids. The ladder in the picture obviously heels off as proven by the absence of paint and the presence of sandy material clinging to the bottom side of the ladder just to the rear of the cutter basket. Production tapers off when heeling occurs because the cutter cannot be let down any further to cut more material loose. The operator, after fruitless attempts to lower the ladder, tries to swing sideways and finds that the ladder cannot be swung because it is digging into the bank upon which it is resting. His only solution is to pick up the ladder and look for another spot where the cutter can be brought into contact with material. Naturally production has gone south while all this maneuvering is going on. Usually, if heeling off happens once it will happen again. And again. See Willard says....*The Dutchman* for solutions to heeling off.

More Design Deficiency! The arrangement of the cable rigging that supports the end of the ladder imposes unnecessary strain on all parts of the hoist system. Eventually, one abused component will be overloaded where upon it will fail and the ladder will fall.

The problem arises due to the angle of the three-part cable rigging as it extends from the hoist frame block near the top of the picture to the hoist bail block on the ladder. That angle, about forty five degrees off of vertical when the cutter basket is just clear of the water, creates far higher loads than would be the case if the angle were five degrees or less. The load on the system shown in the photo will increase dramatically if an effort is made to raise the ladder higher than shown. The rigging angle could easily be reduced to near zero by attaching the bail block further back on the ladder.

The open-bladed cutter basket has no sifting ability. Note the large opening between the blades. An oversized rock can pass between the blades, enter the dredge system and cause downtime when it lodges in the pump.

More Safety, Safety, Safety! The ladder support safety cable is not connected to the ladder. The lone, wimpy cable hanging vertically from the top of the hoist frame is obviously meant to support the ladder when the rigging system is out of service. While it is not clear in the picture above, there is a shackle hanging in the loop at the bottom of the cable and it is not connected to anything.

Sometimes its the little things that cause really big problems! Note the two clamps on the ladder safety support cable. Only the top one is installed correctly. Note the three clamps that dead end the hoist cable. Only the upper two are installed correctly.

When this picture was taken, some twenty years ago, ladder safety cables were seldom connected unless the rigging system was going to be taken out of service. Today, MSHA inspectors consider it a violation if safety supports are not connected whenever personnel present on the ladder **for any reason**.

What makes the correct way correct? See Figure #2. Cable clamps should always be installed with the saddle half bearing on the loaded section of the cable. The saddle half grips without distorting the cable's strands while the U-bolt half of the clamp always crimps some of the strands and reduces its rated strength.

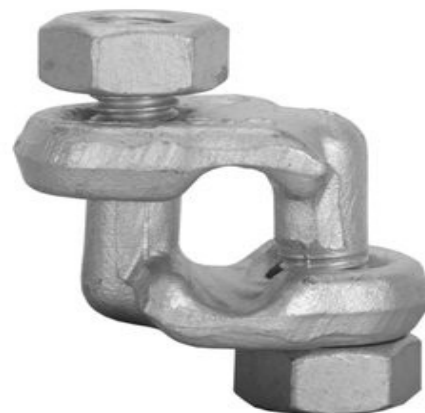
Figure #3

Double-saddle cable clamps are available but seldom seen. See Figure #3. These clamps feature two saddles so they cannot be installed incorrectly.
